INDOOR AIR QUALITY REASSESSMENT

**Memorial Middle School
502 Cabot Street
Beverly, MA 01915**

Prepared by:
Massachusetts Department of Public Health
Center for Environmental Health
Bureau of Environmental Health Assessment
Emergency Response/Indoor Air Quality Program
October 2004

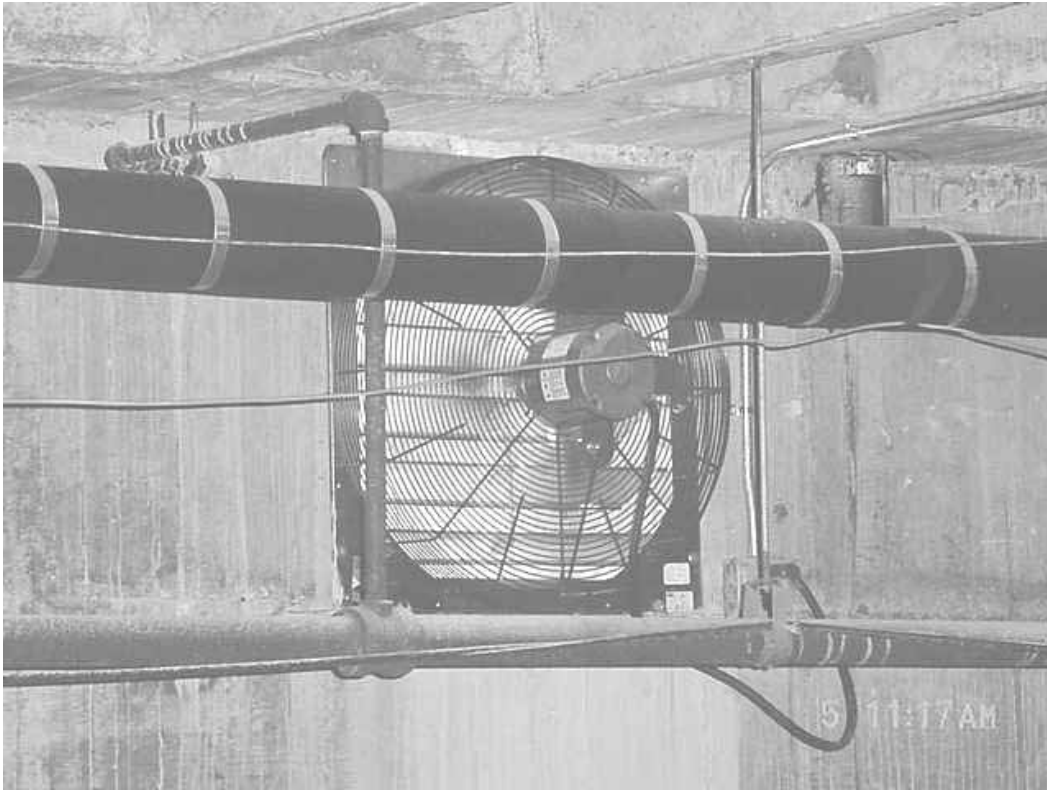
Picture A-1

Action: Mechanical ventilation was installed in the crawlspace to place the area under negative pressure (Picture A-1).

Exhaust Fan Installed in Crawlspace

- 4. Consult an HVAC engineering firm to determine the feasibility of providing mechanical exhaust ventilation to the crawlspace. The crawlspace should be placed under slight negative pressure to prevent air penetration into occupied spaces.**

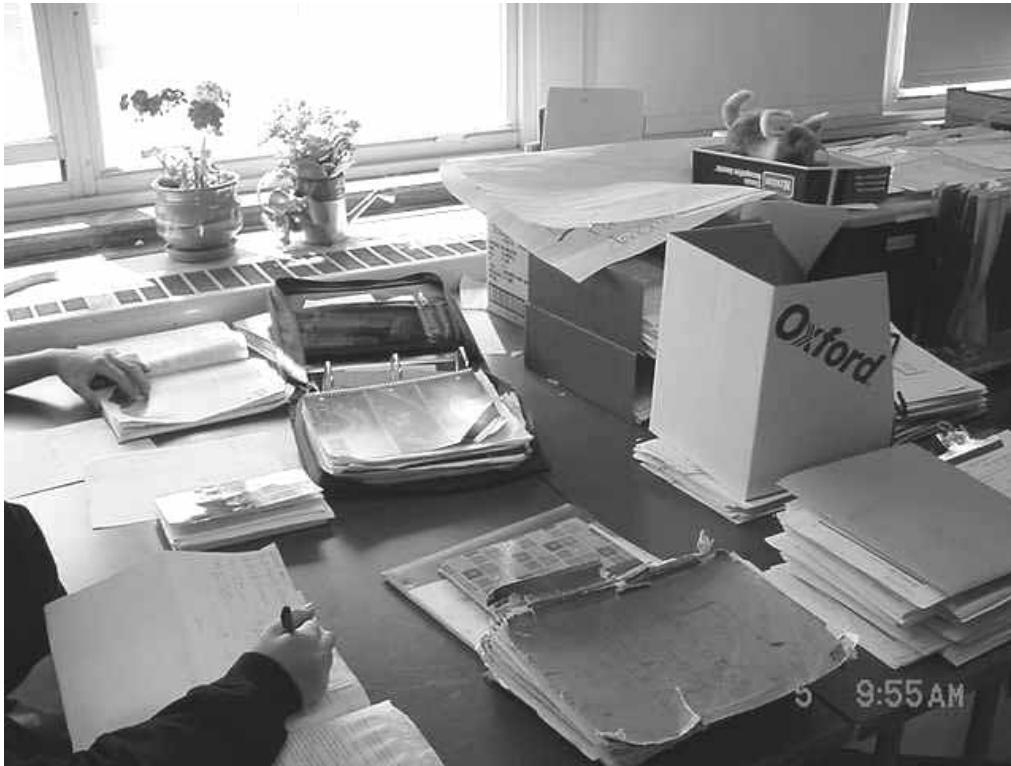
Picture A-2

Table in front of Univent Return Vent, Also Note Plants on Univent Air Diffuser

- 8. Remove all blockages from univents and exhaust vents to ensure adequate airflow.**

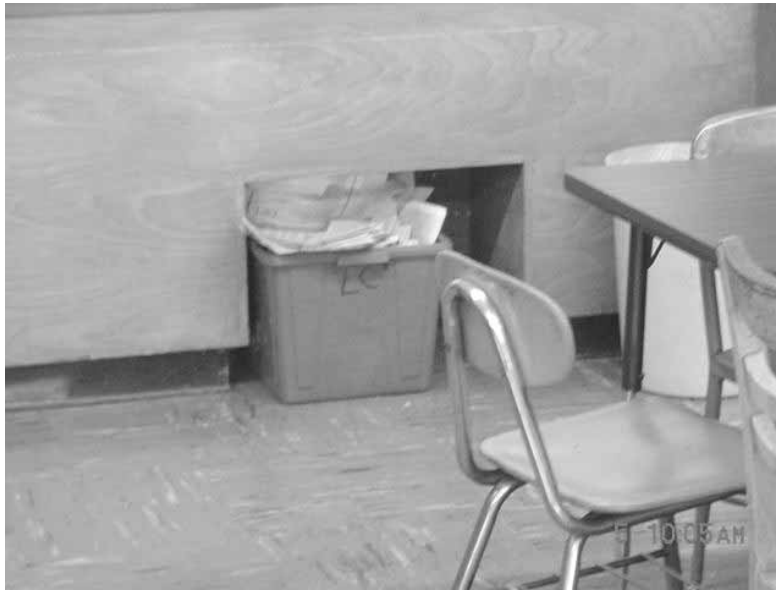
Picture A-3

Exhaust Vent “Cubby” Used for Storage of Recycle Bin

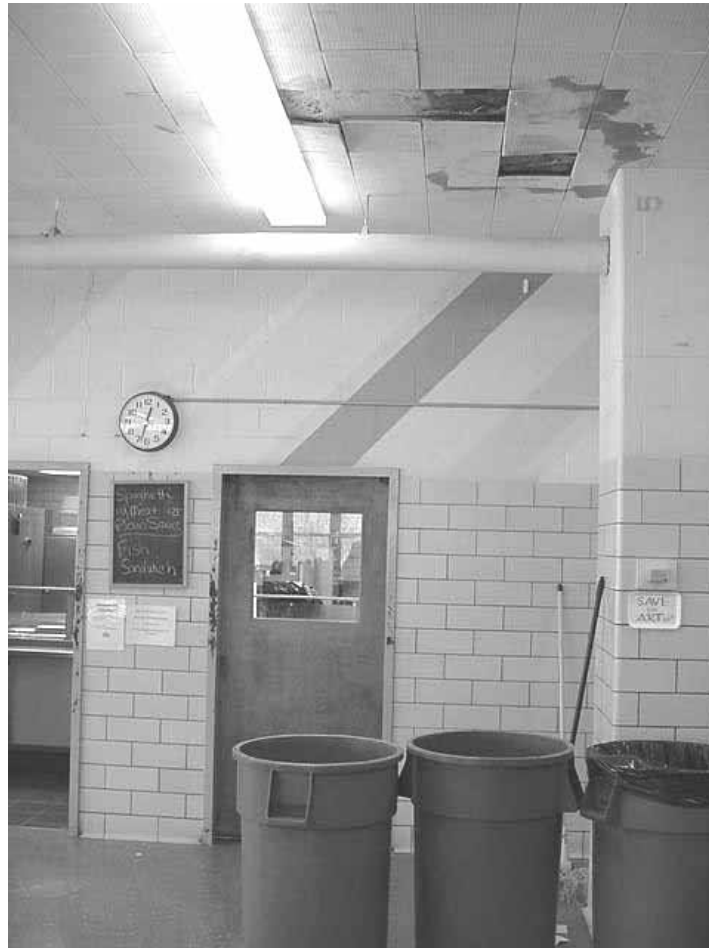
Picture A-4

Action: Roof repairs have been made with the exception of the kitchen/cafeteria, which continues to have active leaks (Picture A-4). At the time of the assessment the BSD was soliciting quotes to repair/replace the roof in this area.

Active Leaks being Drained into Garbage Barrels in Cafeteria

3. Remove water damaged ceiling tiles in cafeteria and in room 145. Continue to drain active leaks until roof repairs are made. Examine the areas above and around these tiles for mold growth. Disinfect areas of water leaks with an appropriate antimicrobial.

- 11. Ensure all roof leaks are repaired. Repair/replace missing/damaged flashing along roof. Replace any remaining water-stained ceiling tiles (for dropped ceilings). Examine the areas above and around these tiles for mold growth.**

Disinfect areas of water leaks with an appropriate antimicrobial.

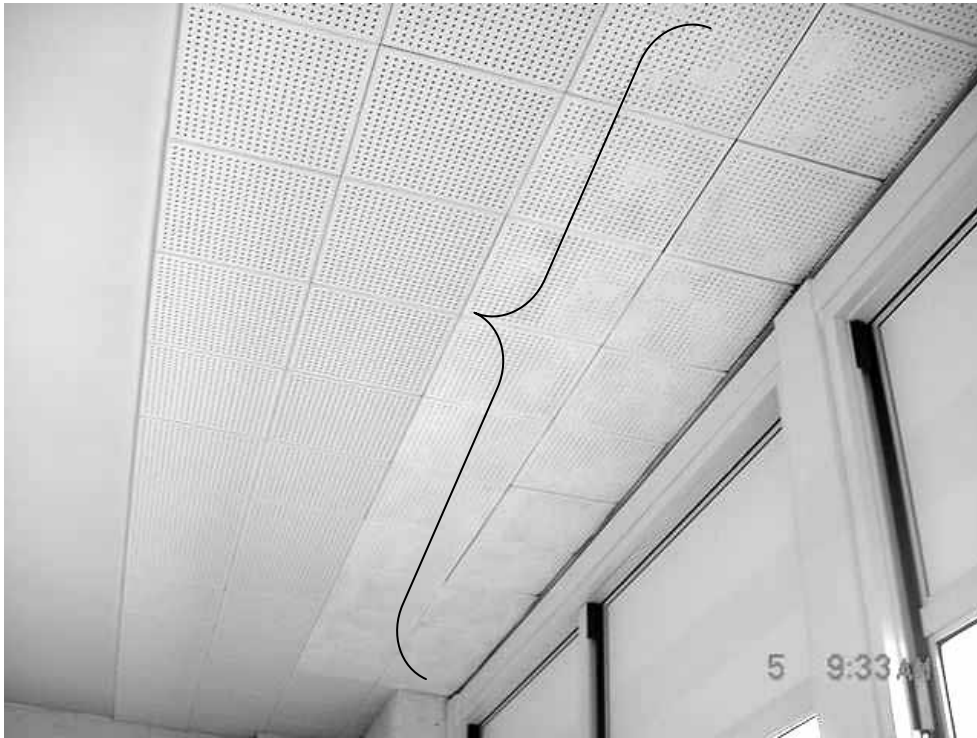
Picture A-5

Action: Water damaged ceiling tiles were replaced in a number of areas. Some tiles appeared to have been sealed/painted (Picture A-5). The cafeteria, auditorium and some classrooms continued to have water damaged ceiling tiles. According to BSD officials, tile replacement for the auditorium is scheduled for FY 05.

Painted/Sealed Water Damaged Ceiling Tiles (First two Rows against Windows)

- 12. For removal of tiles directly adhered to the ceiling, such removal would be considered a renovation activity that can release particulates and spores in particular, if the material is moldy. Replacement of ceiling tiles may involve glues that contain VOCs. In order to minimize occupant exposure, repairs should be done while the building is unoccupied.**

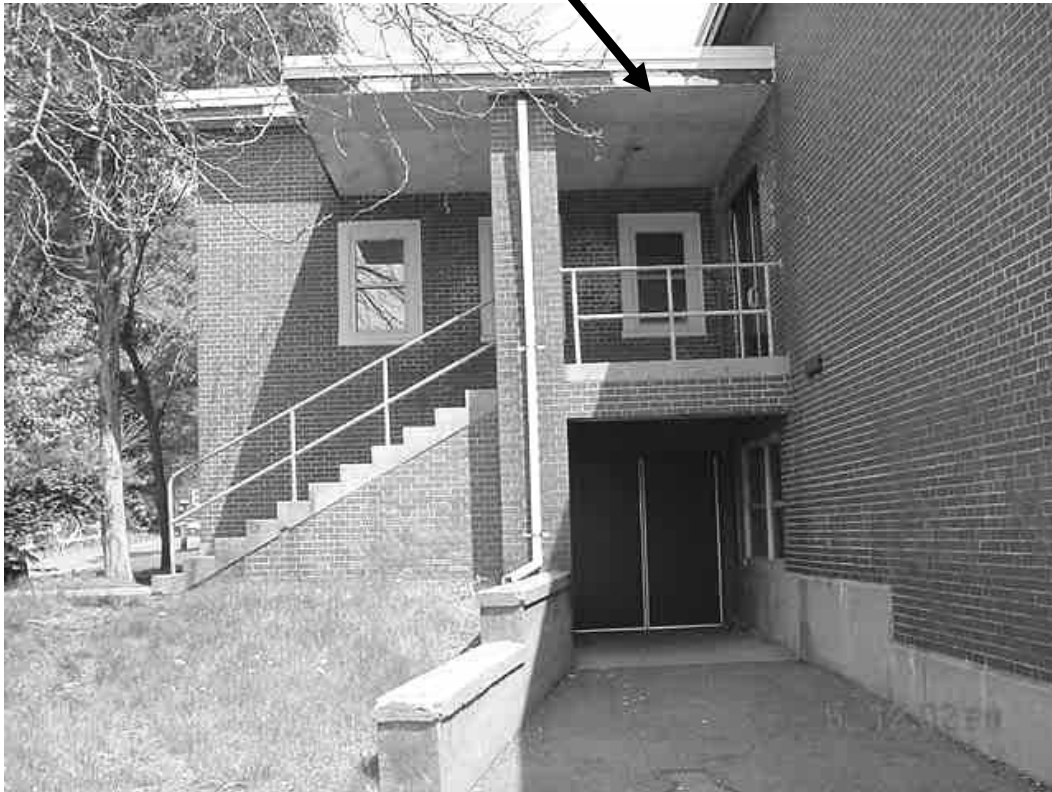
Picture A-6

Action: The downspout was reinstalled (Picture A-6).

Reattached Downspout

- 13. Reinstall missing downspout in Picture 14 to direct rainwater away from the foundation.**
